# RESTORATION IS IN THE BANK

Erosion along Valley Creek's bank is the primary culprit of changes to the creek's health. Sand, silt, and sediment are all enemies of clean water because they carry harmful contaminants and pollutants that affect the creek's ecosystem. Money is available to assist landowners along the creek who are willing to participate in Valley Creek's restoration. Some possible restoration projects are pictured here.

VALLEY BRANCH  
WATERSHED  
DISTRICT

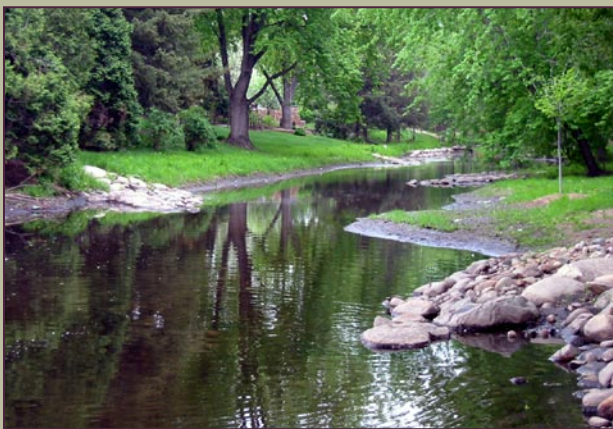
## NATURAL STREAM BUFFERS

The stream bank is held in place by deep-rooted vegetation protecting the bank from erosion. Runoff is reduced and wildlife habitat is created by colorful native plants and shrubs.

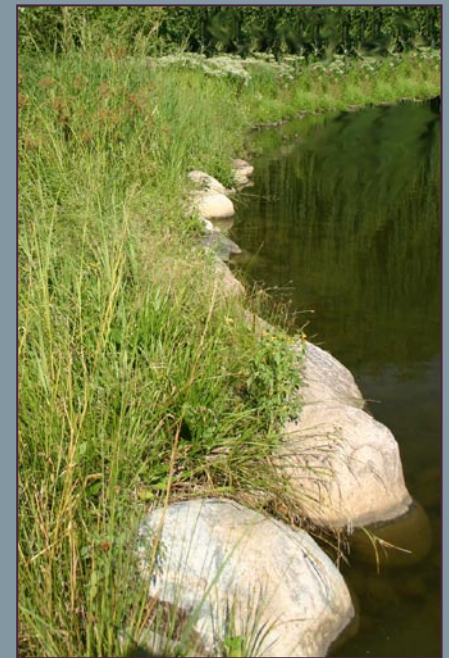
## BANK STABILIZATION

Before and after photos along the Rum River in Minnesota, demonstrate the transformation of a severely eroded site to a stable river bank planted with beautiful native vegetation.

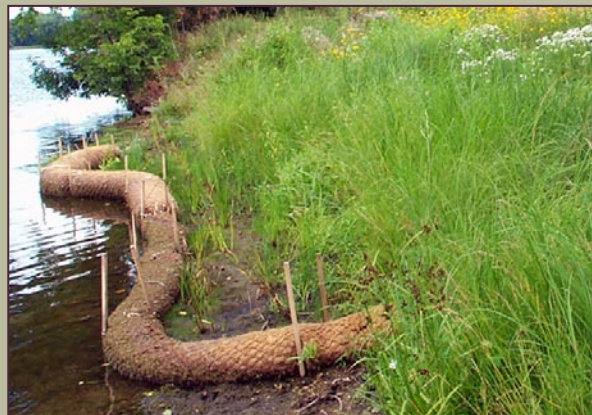
## BANK PROTECTION

Coconut fiber rolls protect the lower portion of the bank when channel flow undercuts the bank. This type of erosion is common along Valley Creek.

The coconut fiber roll also provides temporary bank protection so that vegetation can become established. This type of measure is best suited for sunny sites where channel velocity is relatively low.

Boulders, such as those pictured at far right, can also be used to protect a bank from undercutting.
